The Hilltop, Donated by Mildred and Hale Whitaker Historic Structures Report Lakeside Linkage Preserve

Historic Structures Report - Lakeside Linkage Preserve
Contract #522677 Task Order 1, Task 3

ICF Jones & Stokes
April 2008

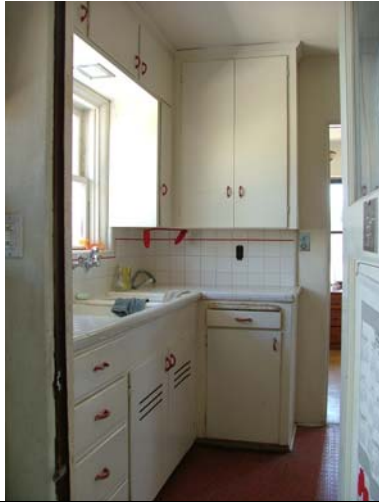
Figure 1. Kitchen, interior

The original light fixtures and design elements located on the exterior and interior of the house (see figures 1-9) appear to be original and are in good condition. Some of the interior details include a wood beam ceiling in the large living room, decorative metal peephole on the front door, and a large intrusive fire place that is composed of the same local rock, all of which appear in good condition.

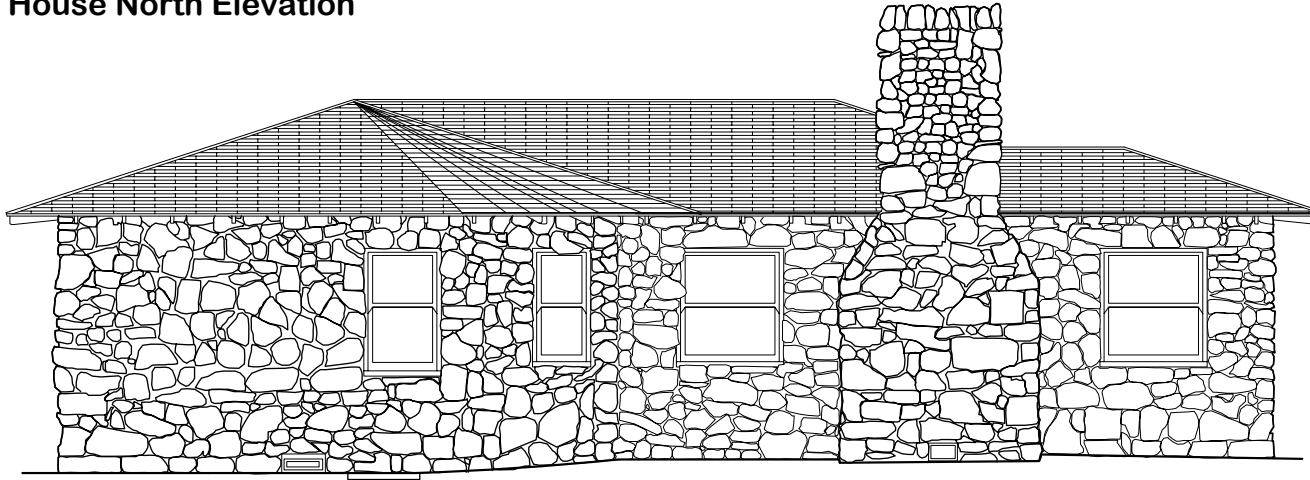
Figure 10. North Elevation

North elevation is dominated by rock chimney and features an unusual $\frac{1}{4}$ round wall with conical roof element.

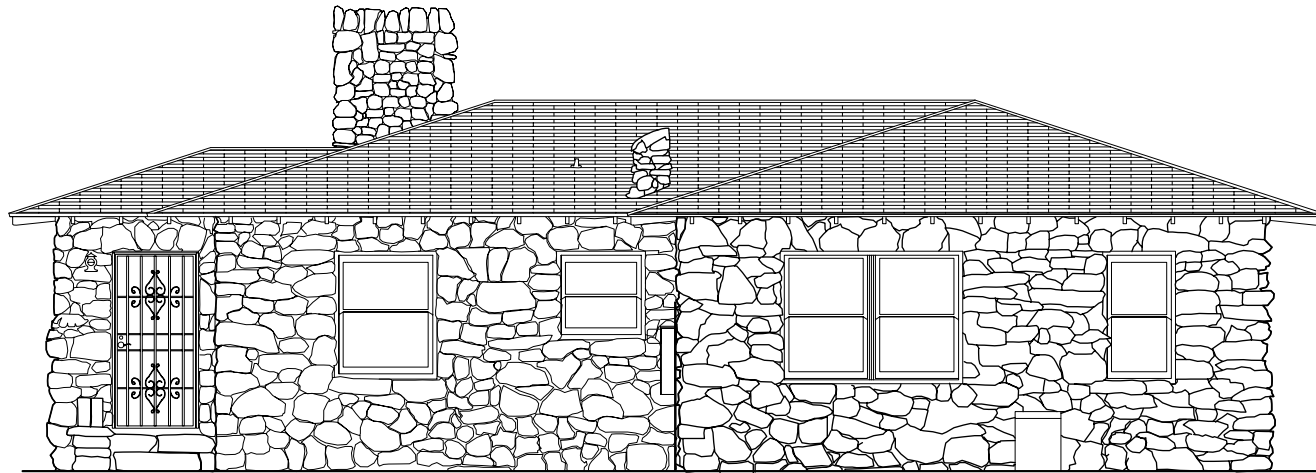
Figure 11. South elevation

South elevation is in three facets. Front door is anything but grand. A modern marker has been added next to this elevation commemorating the Whitakers and their love of this place.

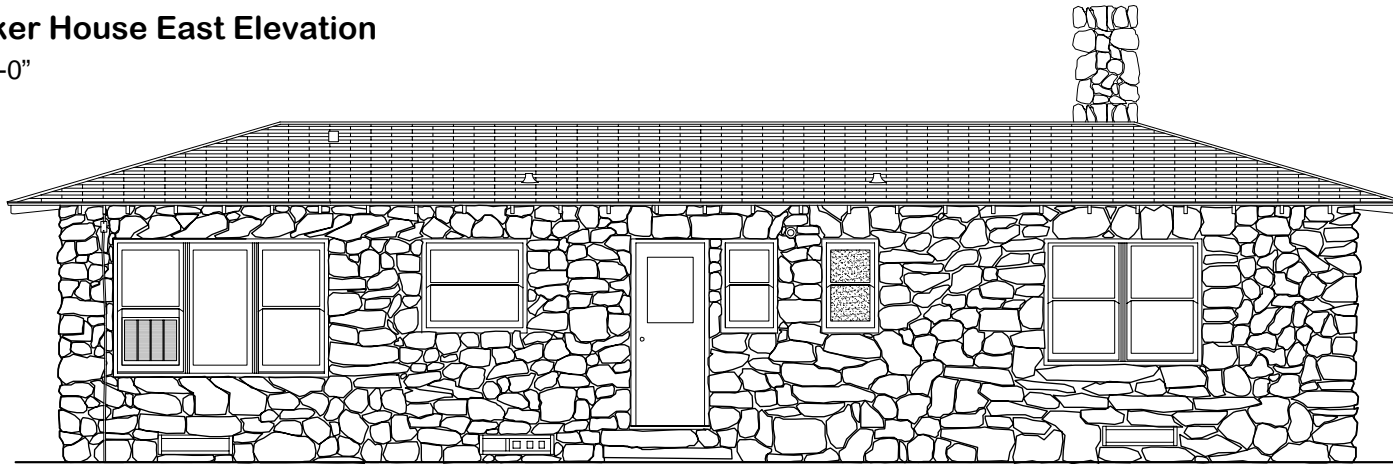
Figure 12. East elevation

East elevation was probably the functional entry for the residents as the entry door leads into a service porch with its own utility sink. The house has no heat other than period electric wall heaters in the bathrooms. A window air conditioner has been fitted into a corner of the dining room.

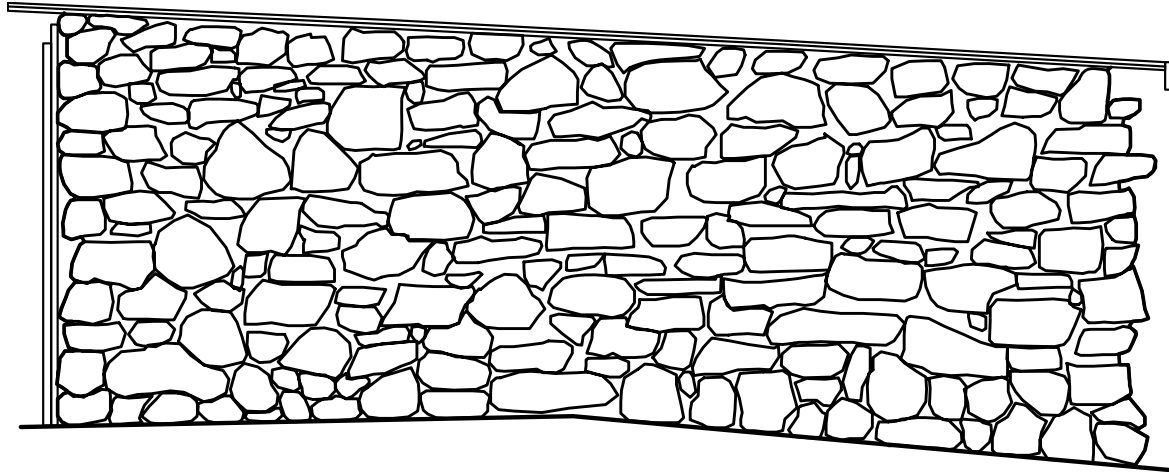
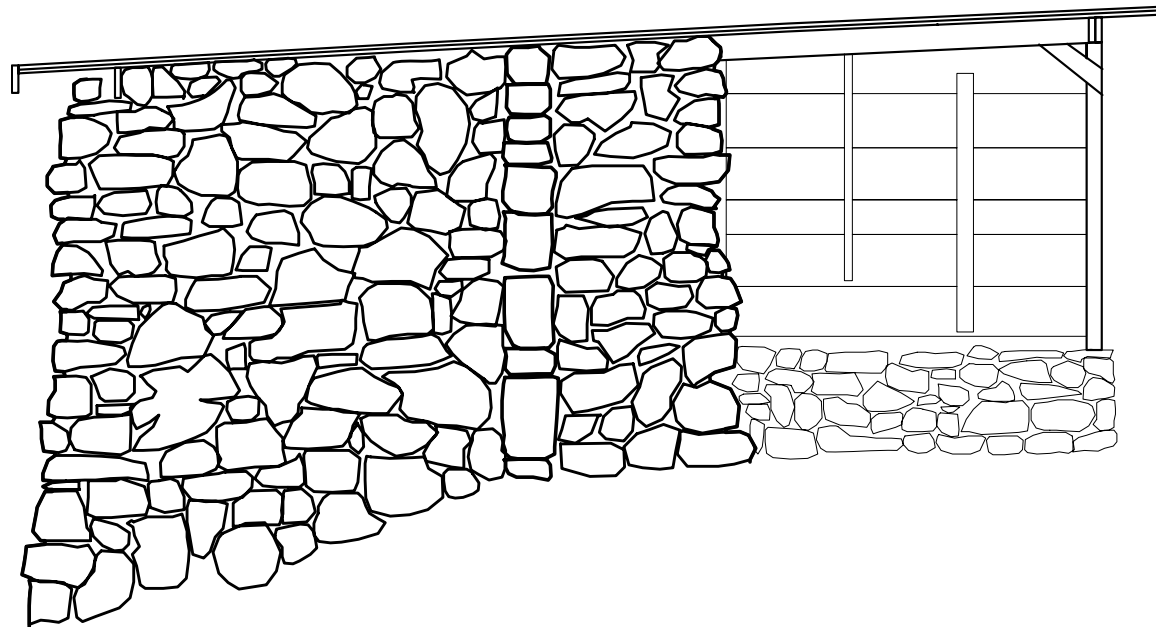
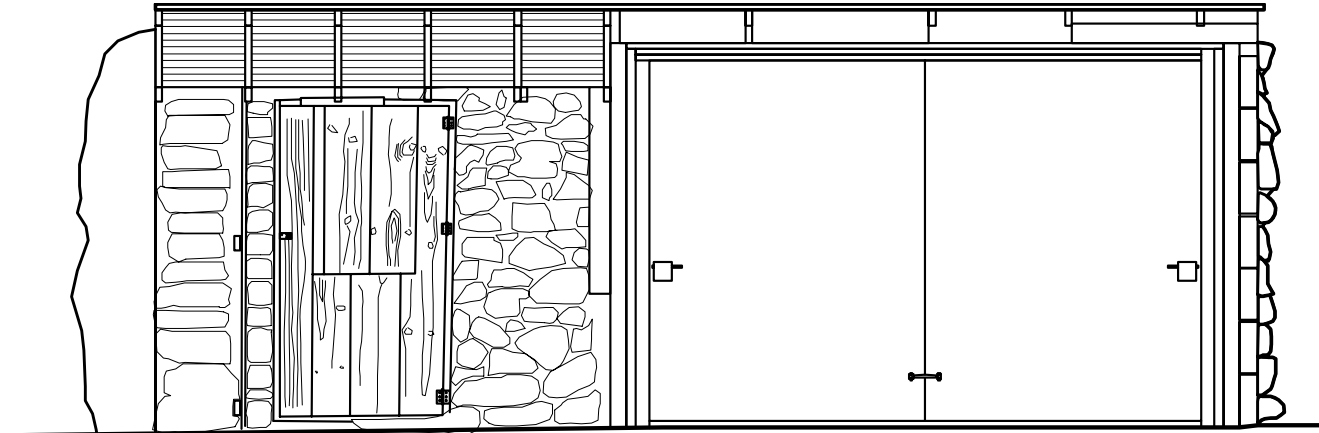
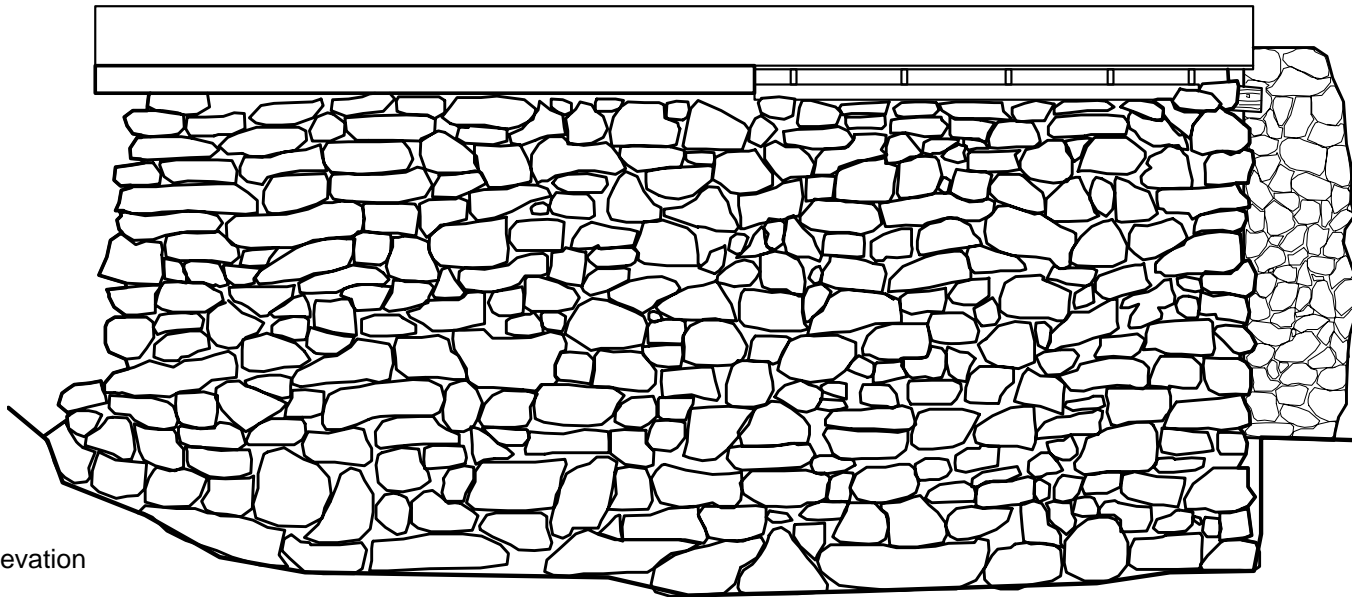
The garage shows some signs of neglect; the roof structure is beginning to come apart. However the damage is not major and is well within the skill set of any carpenter to affect matching repairs.

As mentioned previously, the garage roof framing is in need of a small amount of immediate repair. Other than that the two buildings are in sound stable condition and no other maintenance is called for immediately.
